CIVIL ENGINEERING STUDIES
Hydraulic Engineering Series No. 55

Hydraulic Model Study for the Restoration of Batavia Dam, Fox River, Illinois

Abstract

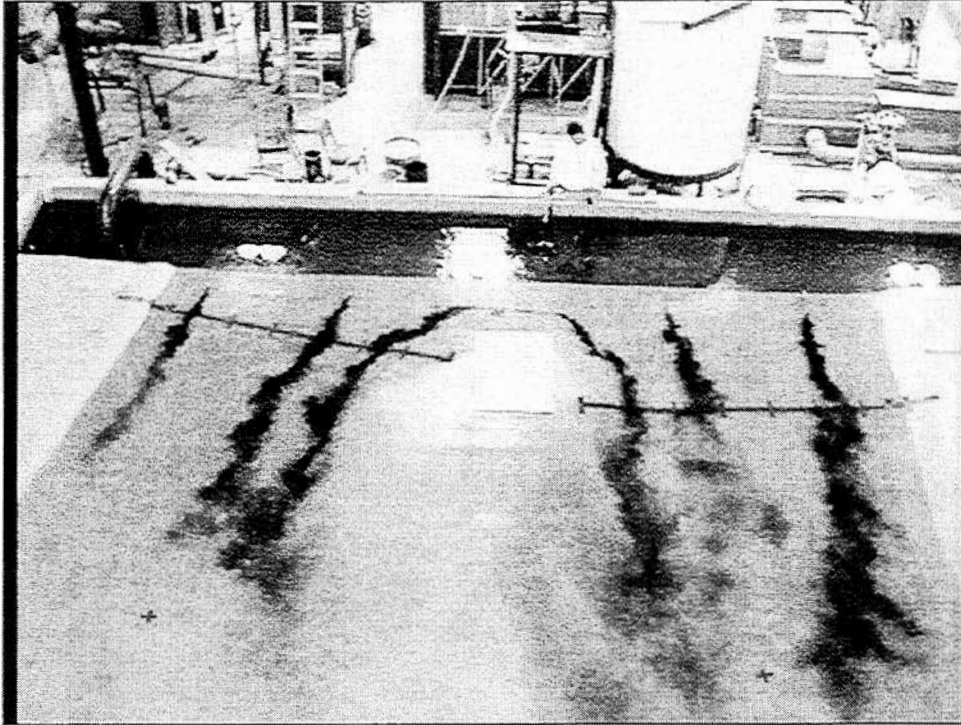
Figure 3.6. Existing condition - Visualization of flow split around Duck Island - 10 year flood (8500 cfs)

Figures 3.6 and 3.7 show some results of the dye tracer study conducted for the 10 year flood. Conditions here were similar to those described above for the 2 year flood. Although not visible in

Figure 3.6, vortex shedding from the right side of the island was again prominent. The rightmost dye plume behaved in a similar manner, traveling directly to the breach. In general, the 10 year flood developed visibly more mixing than experienced in the 2 year flood. However, the wake effects of the island continued to cause the left and right extremes of Batavia Dam to pass the majority of the flow while the central portion of the dam took only a relatively small portion of the flow.

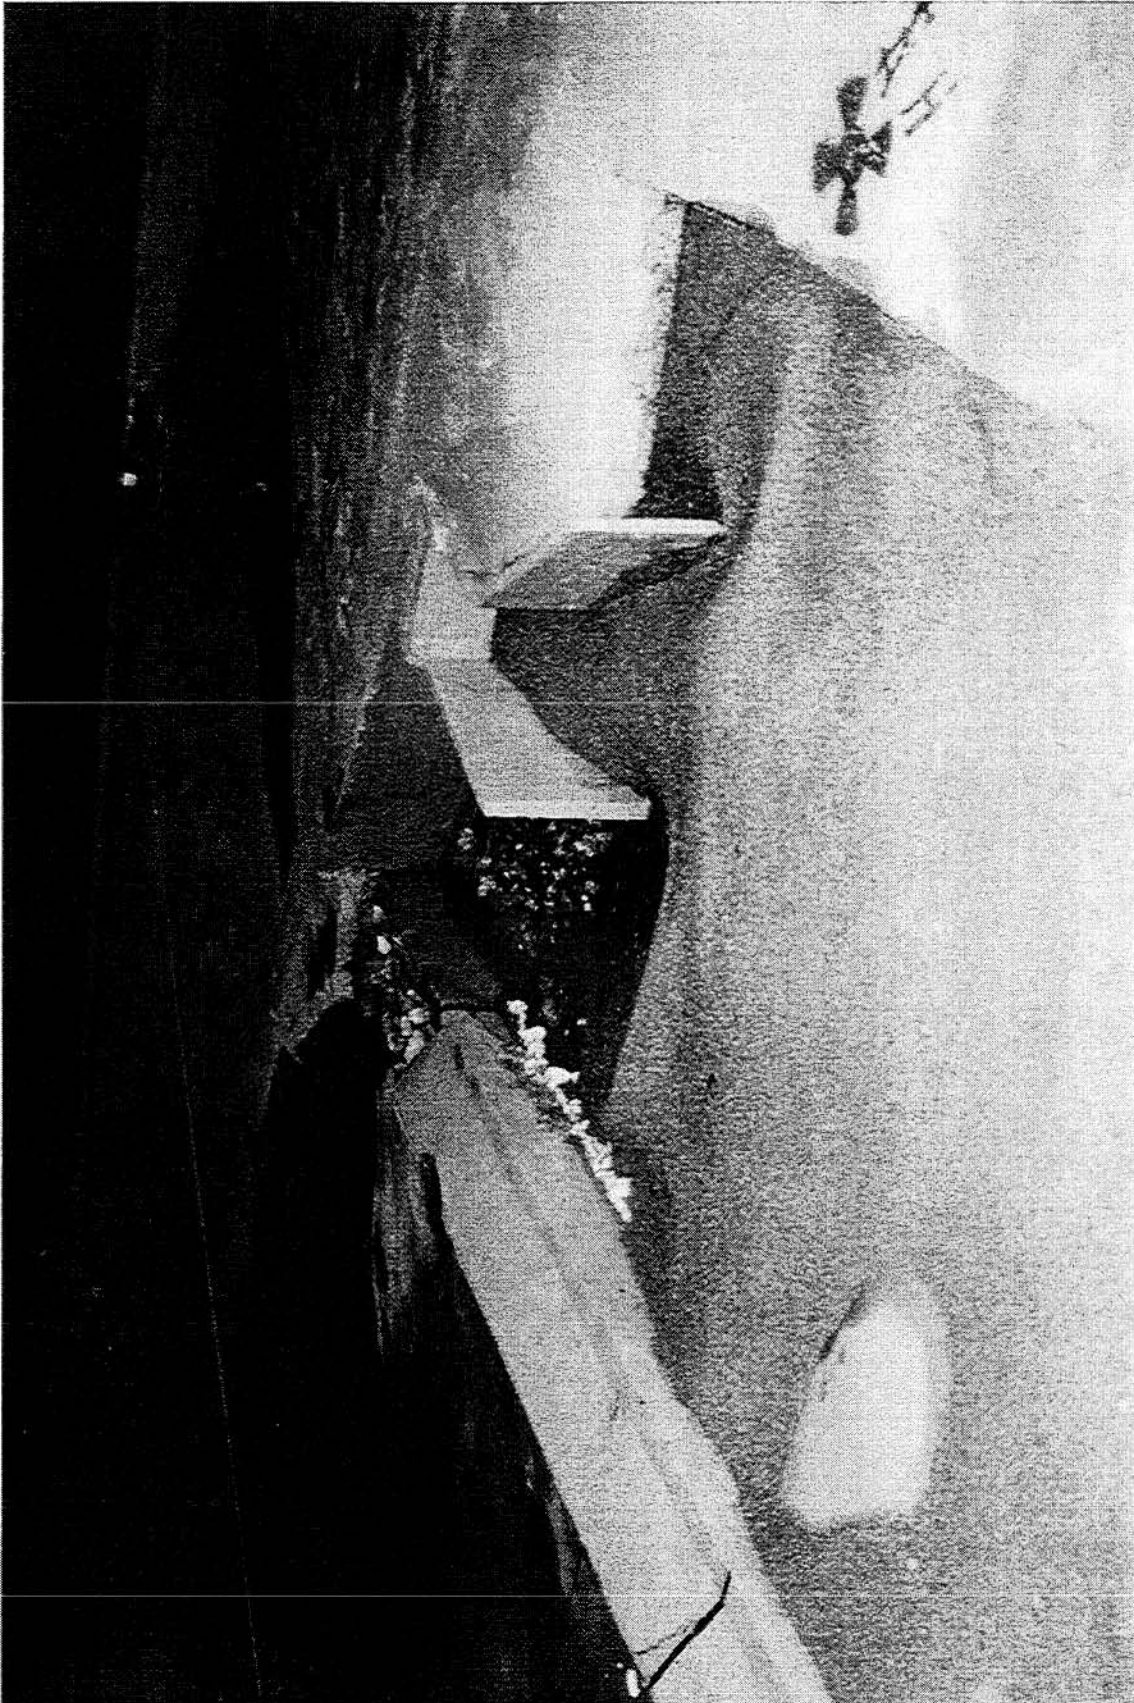
Figure 3.32. Scour hole developed downstream of dam breach

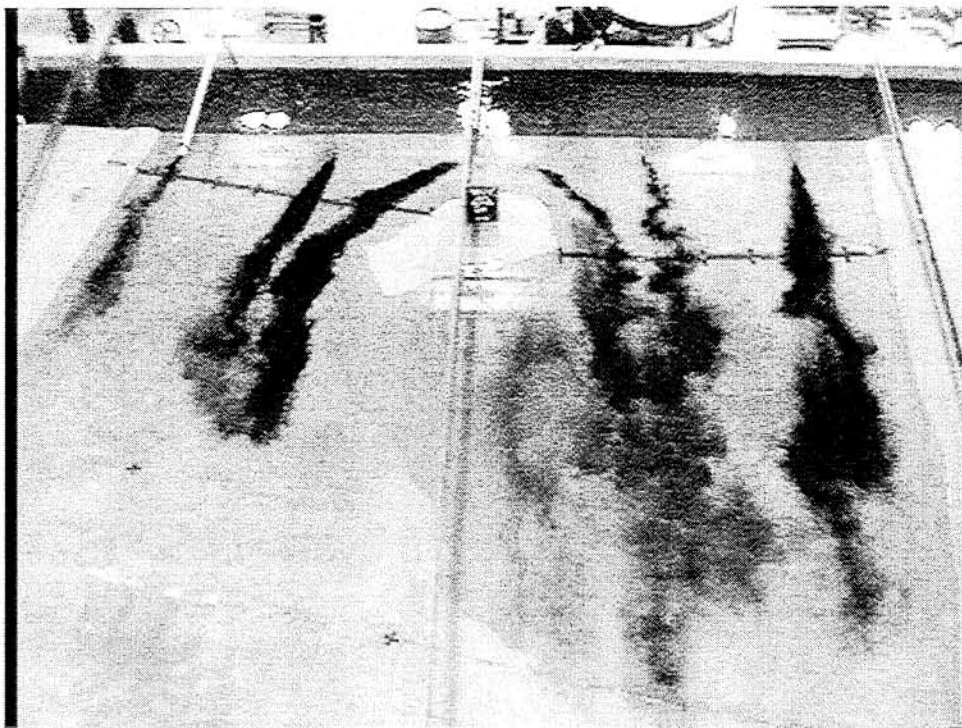
Figure 3.34. Baseline condition - Visualization of flow split around Duck Island - 2 year flood (5700 cfs)

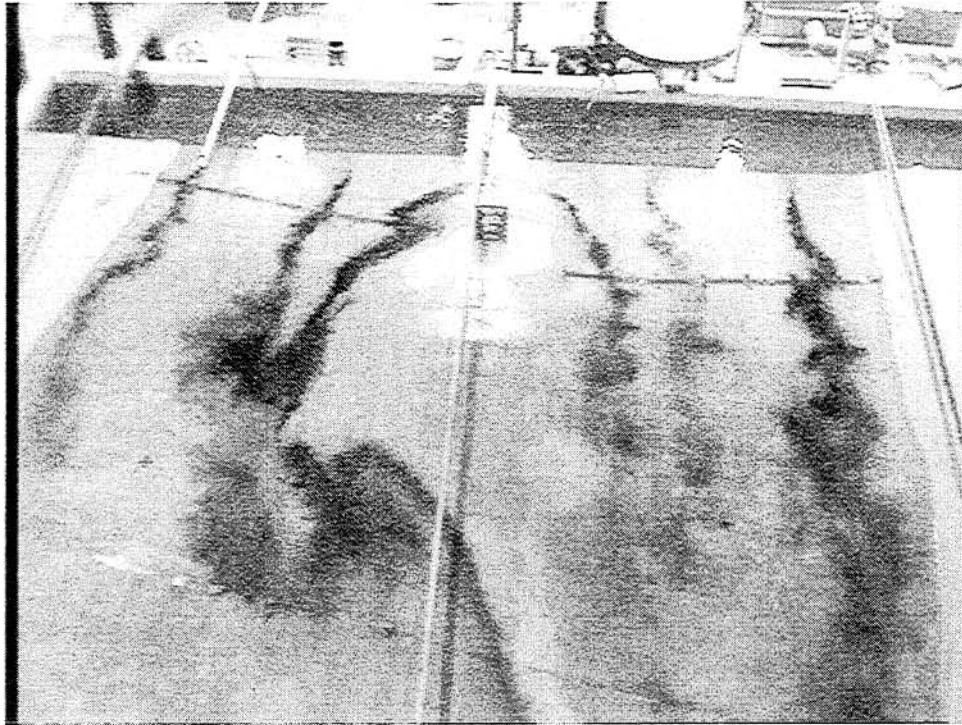
Figure 3.36. Baseline condition - Visualization of flow split around Duck Island - 10 year flood (8500 cfs)

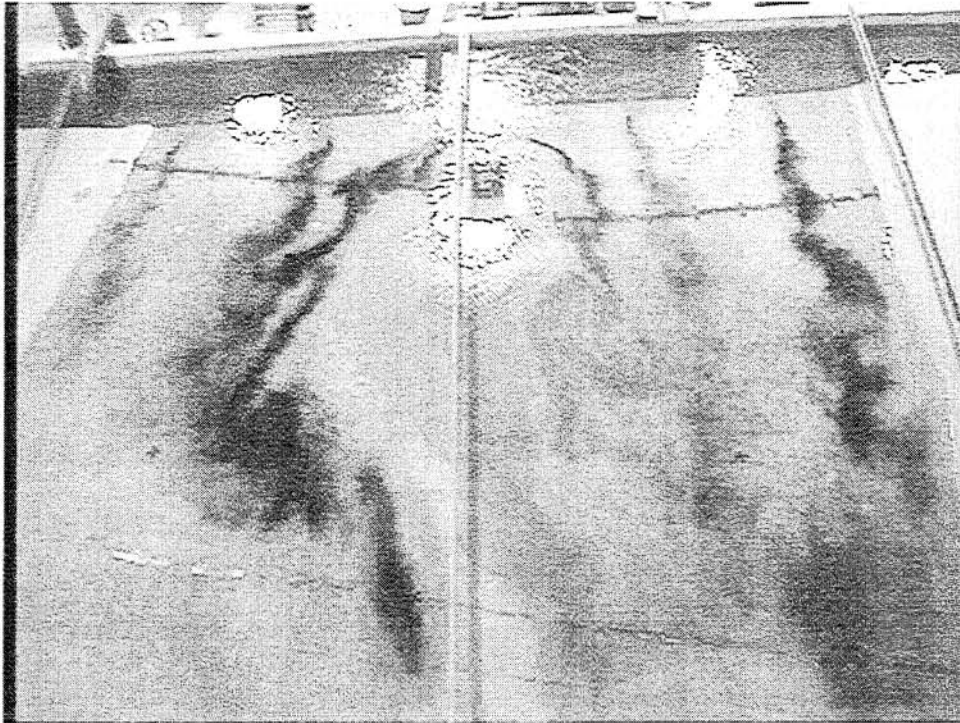
Figure 3.40. Baseline condition - Visualization of flow split around Duck Island - 100 year flood (13500 cfs)

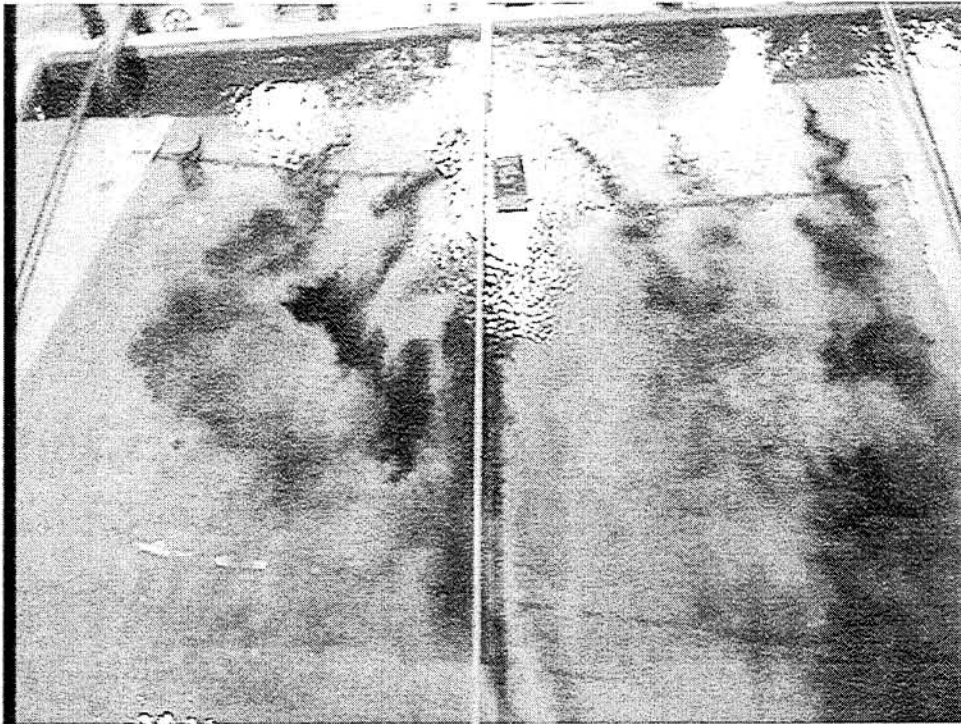
Figure 3.42. Baseline condition - Visualization of flow split around Duck Island - 500 year flood (17630 cfs)

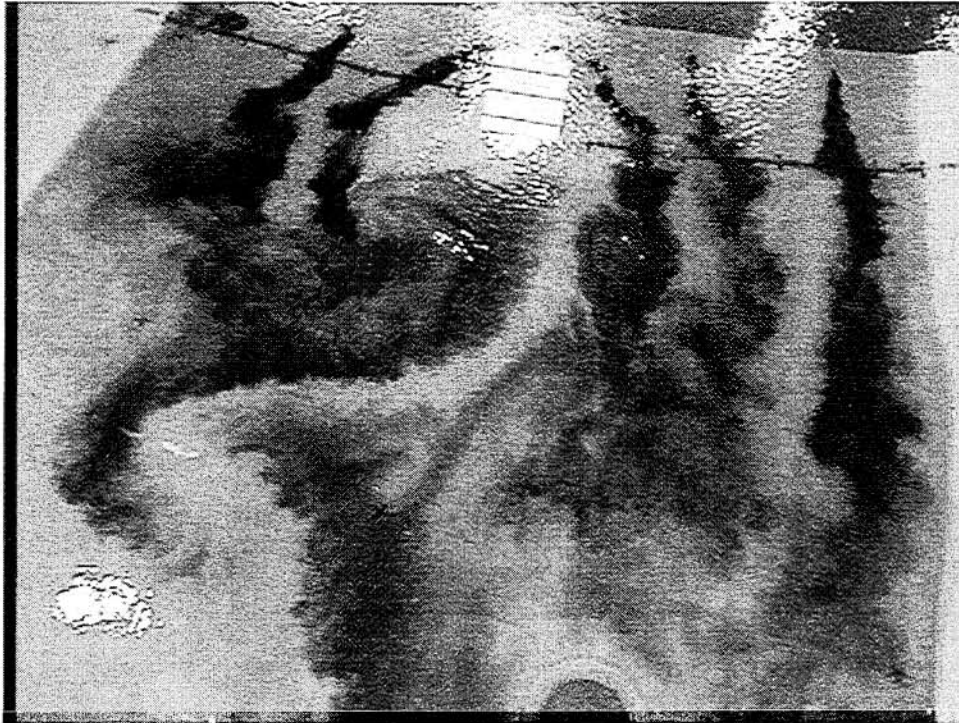
Figure 4.12. Alternative I - Visualization of flow split around Duck Island – 100 year flood (13500 cfs)

Figures 4.12 and 4.13 show results of the dye tracer study for the 100 year flood event. For this flow, several new features were observed. Mixing between plumes in the right channel was more evident. The upstream head of the bathtub spillway played a more active role in passing flow from the right channel. The leftward push originating in the right channel was very distinct, causing the development of an sinuous clear water divided between left and right channel plumes. A similarly

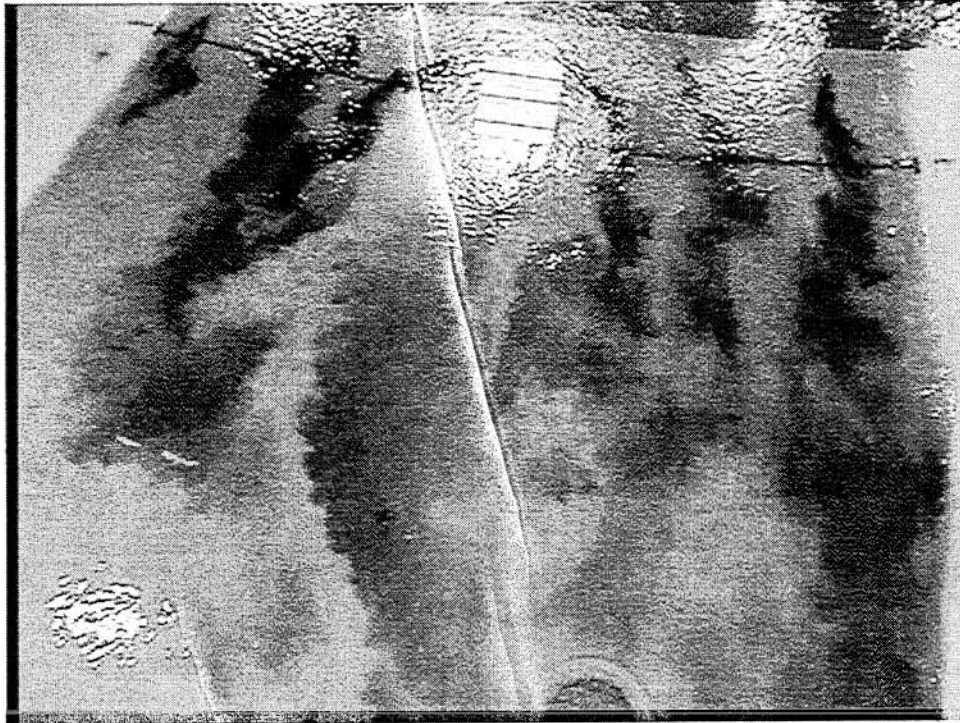
Figure 4.14. Alternative I - Visualization of flow split around Duck Island – 500 year flood (17630 cfs)

Figures 4.14 and 4.15 characterize approach flows for the 500 year flood event. In this case, patterns similar to those for the 100 year event were observed. In general, the flow was more completely mixed. The clear water divide between left and right channel flow remained and continued to show a left channel orientation and approach to the structure. The bathtub spillway clearly played an role in passing dye laden flows from both right and left channels to the downstream end of the structure.

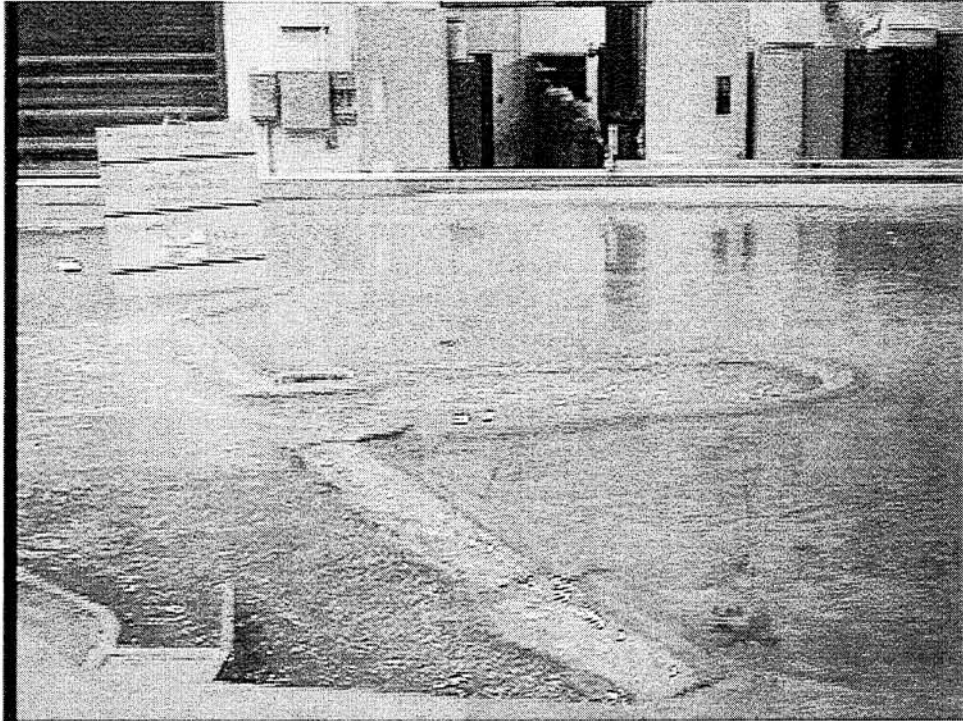
Figure 4.35. Alternative I - Response of bathtub spillway - 500 year flood (17630 cfs)

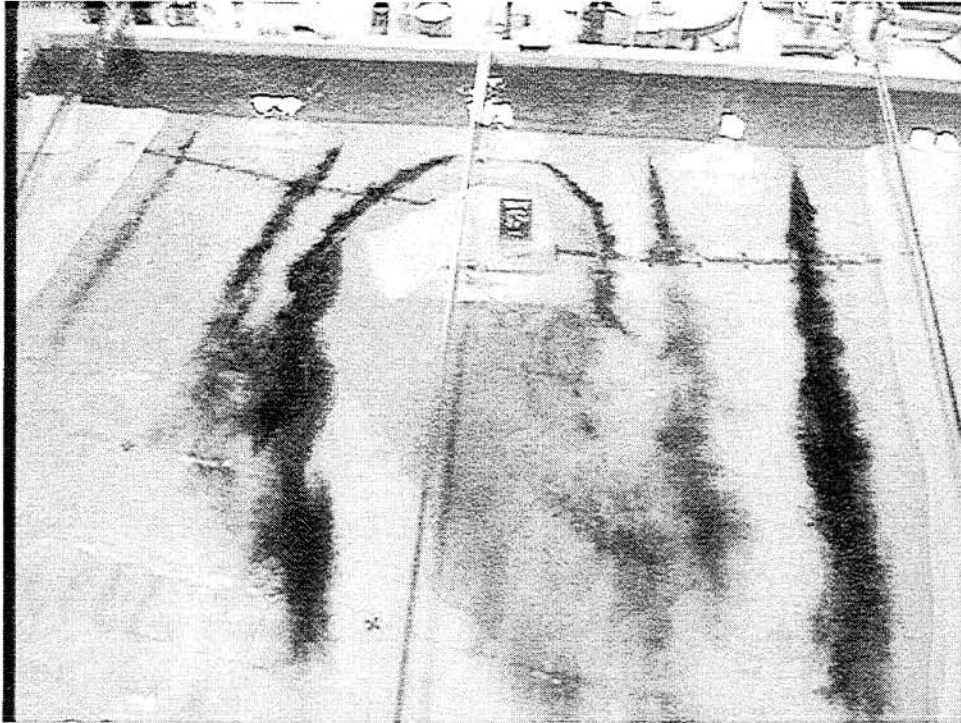
Figure 4.42. Alternative II - Visualization of flow split around Duck Island – 2 year flood (5700 cfs)

The flow orientation and dye tracer development for the 2 year flood are presented in Figures 4.42 and 4.43.

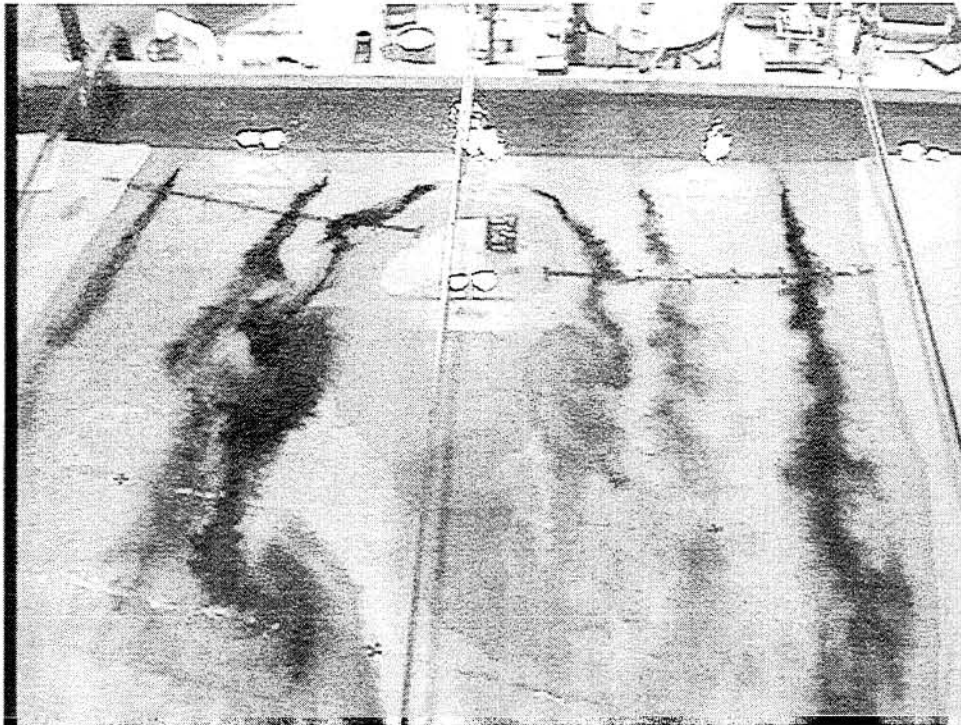
Figure 4.44. Alternative II - Visualization of flow split around Duck Island – 10 year flood (8500 cfs)

Figures 4.44 and 4.45 are photographs of the dye tracer investigation for the 10 year flood event.

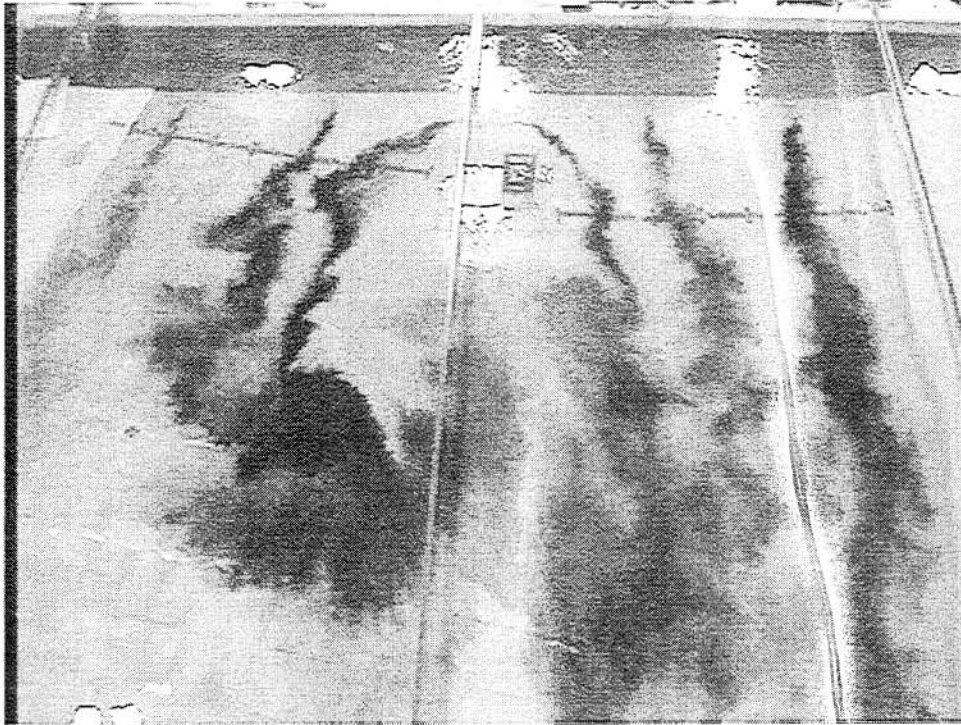
Figure 4.48. Alternative II - Visualization of flow split around Duck Island – 100 year flood (13500 cfs)

Figures 4.48 and 4.49 show the results collected during the 100 year flood dye tracer test of the rock dam.

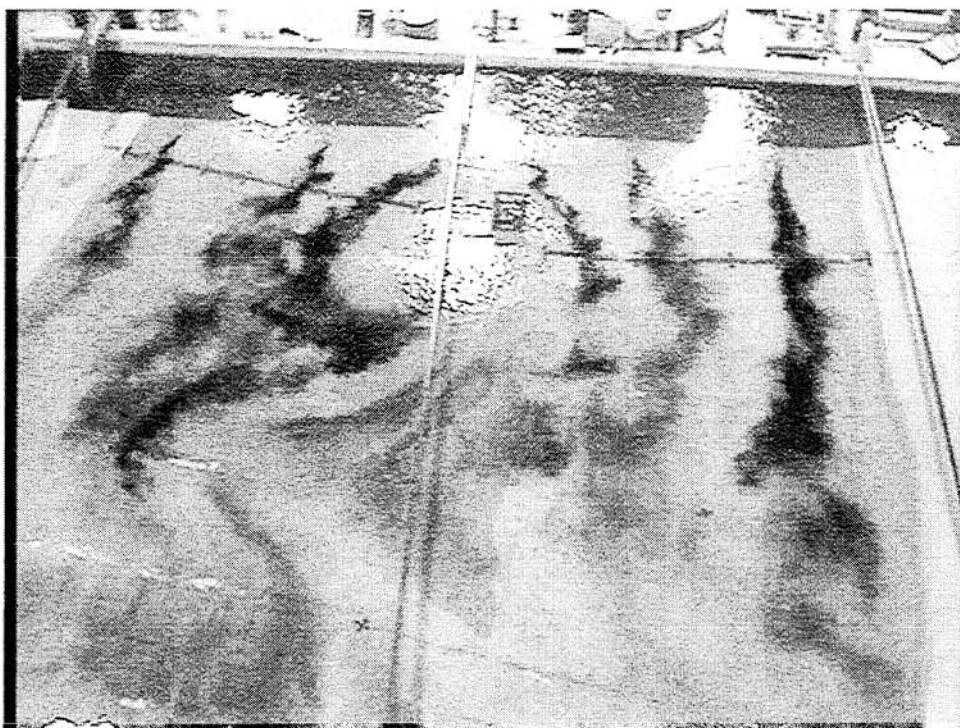
Figure 4.50. Alternative II - Visualization of flow split around Duck Island – 500 year flood (17630 cfs)

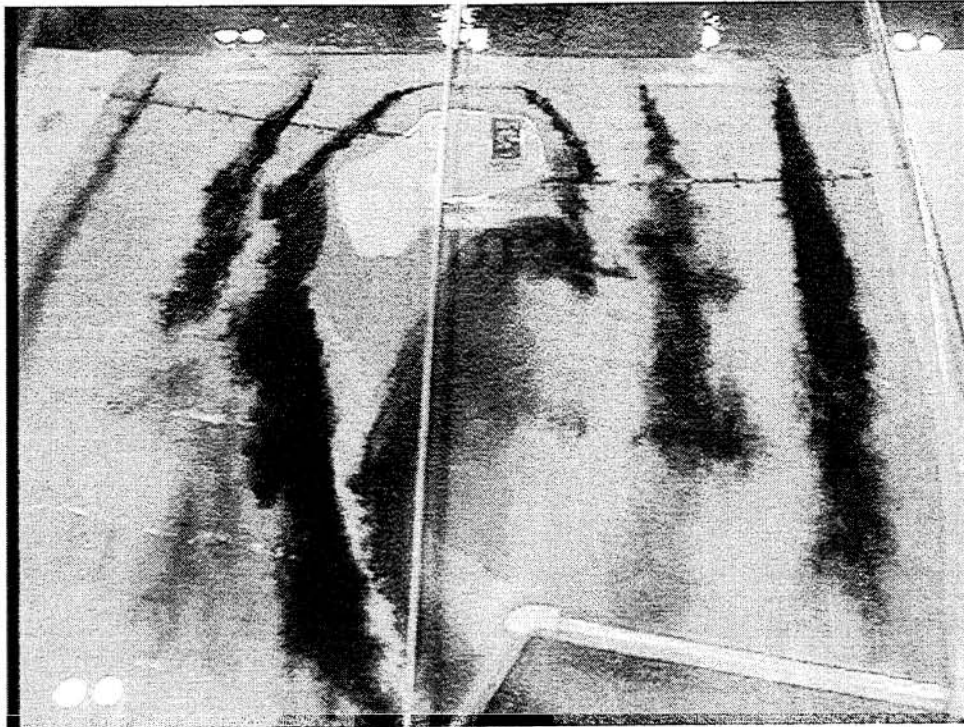
Figure 4.70. Alternative III - Visualization of flow split around Duck Island – 2 year flood (5700 cfs)

Figure 4.70 and 4.71 provide still frame captures of the video collected during the 2 year flood investigation of Alternative III.

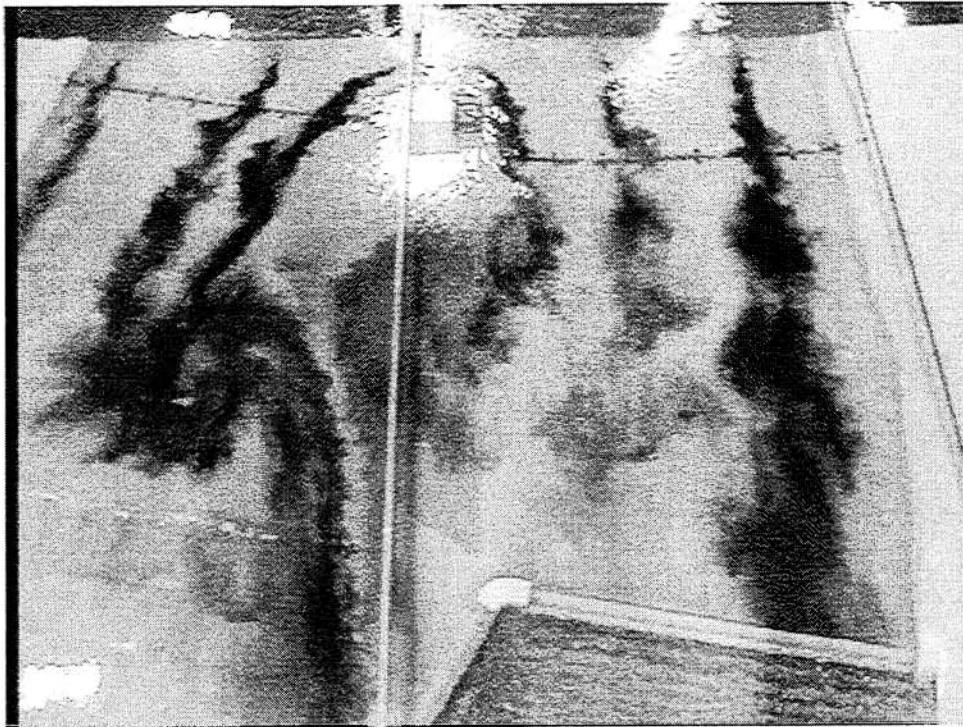
Figure 4.78. Alternative III - Visualization of flow split around Duck Island – 500 year flood (17630 cfs)

Figure 4.79. Alternative III – Visualization of spillway approach flow – 500 year flood (17630 cfs)

Figure 4.78 and 4.79 show the dye tracer results observed for the 500 year flood event.

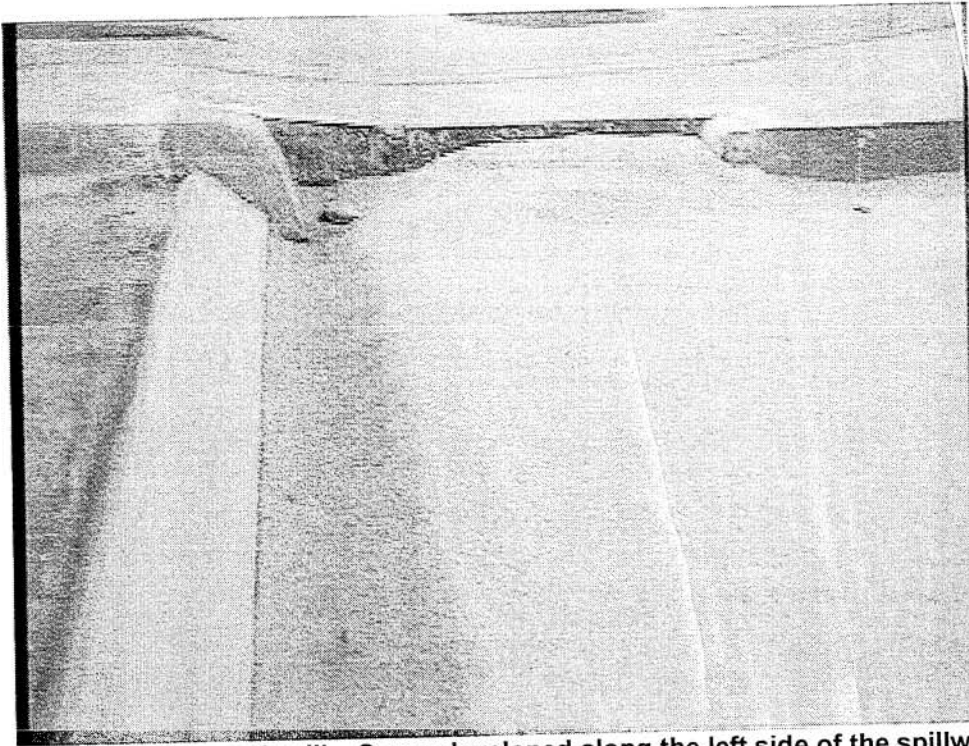
Figure 4.95. Alternative III – Scour developed along the left side of the spillway
